Basic Troubleshooting Tips

Midmark M11 / M9 Bypasses Fill Mode and Overheats. Error Code C983

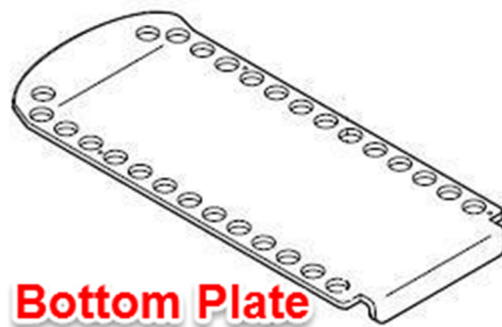
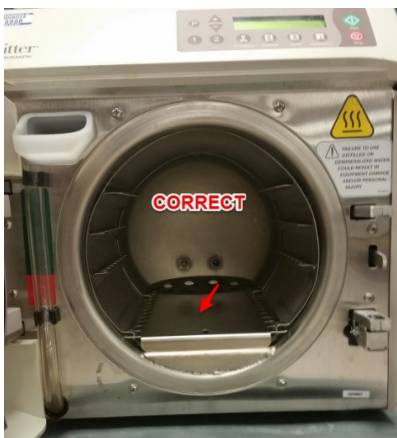
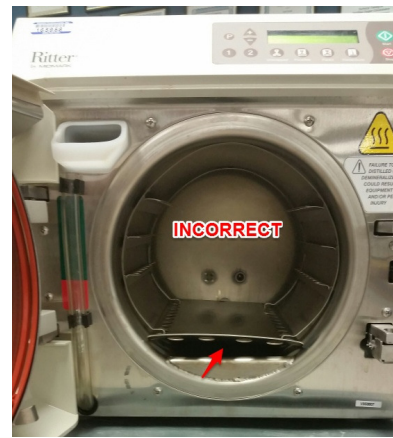
If the bottom plate of an M/11 or M/9 is inserted backwards, the edge of the plate will touch the temperature sensor in the back of the chamber, causing false temperature readings and will result in the autoclave bypassing the fill mode and overheating.

Check to make sure the bottom plate is not inserted backwards.
